Report Number: P WMA 06/D00/00/3423/2

Greater Mangaung Water Augmentation Project Site Visit Report

Xhariep Pipeline Feasibility Study

Site Visit Report

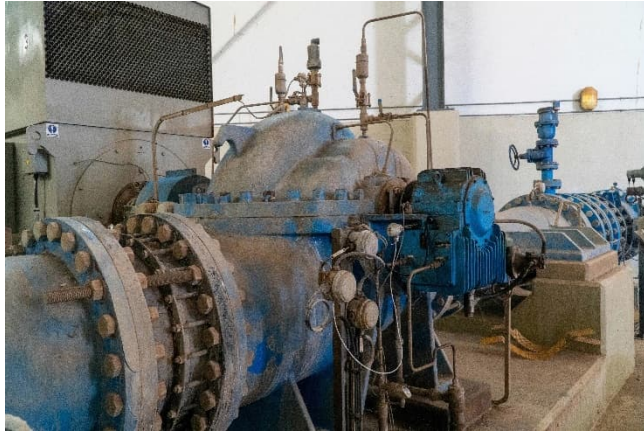
Figure 3-7: New pump set

- ▶ The pumpsets (pump and motor), pipework and valves appear to be in a reasonable condition. The operator did not report any problems with the pumpsets.

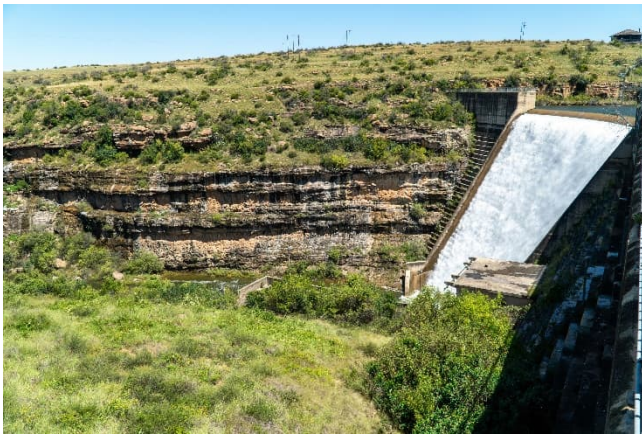
- ▶ Evidence of seepage on the dam wall and roof of the structure on the downstream side of the dam.
- ▶ The outlet works chamber was left open which was a safety risk.
- ▶ Pipework seems to be in good condition.
- ▶ Drawings of the Knellpoort Dam were available in Tienfontein Pump Station.

Figure 3-11: Water seeping through dam wall on right side of image

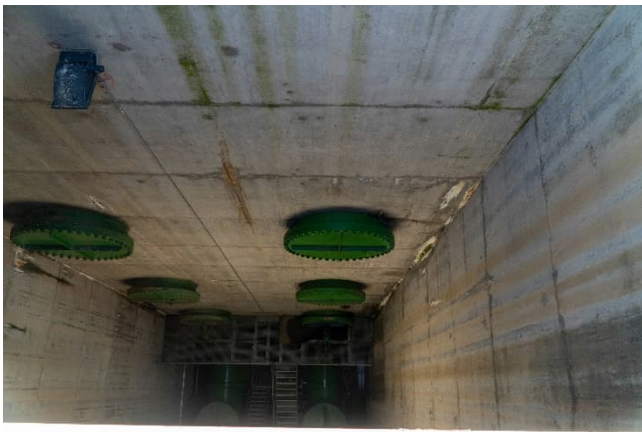
Figure 3-13: Looking down the outlet works chamber/shaft

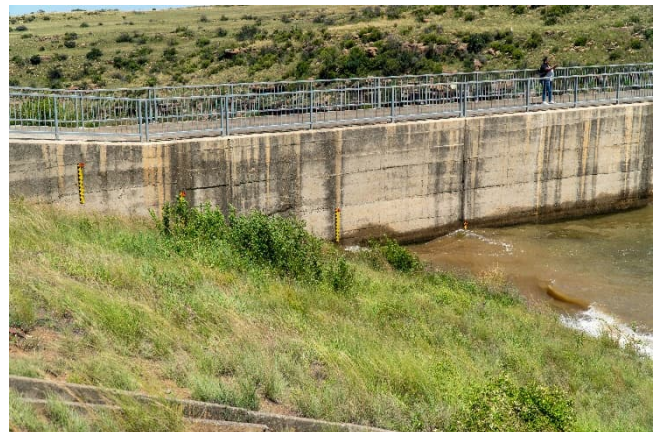
Figure 3-14: Water level of Knellpoort at time of visit

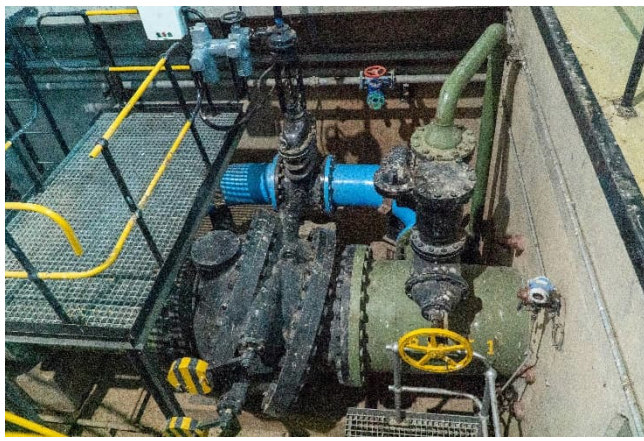
Figure 3-23: New pump set

- ▶ Six vertical turbine pumps are installed.
- ▶ The pump station were upgraded to 4 m³/s not long ago.
- ▶ Siltation problems at the inlet of the pump station prevent the pump station to operate at maximum capacity.
- ▶ Siltation is a major problem for the operators and causes frequent breakages.
- ▶ Pump station building seems to be structurally in reasonable condition, although general housekeeping needs to be attended to.
- ▶ The mechanical and electrical equipment seems to be in good condition although general maintenance and cleaning is required.
- ▶ There are no additional bays for new pump sets to be installed and larger pumps will need to be installed if the capacity of the pump station is to be increased.

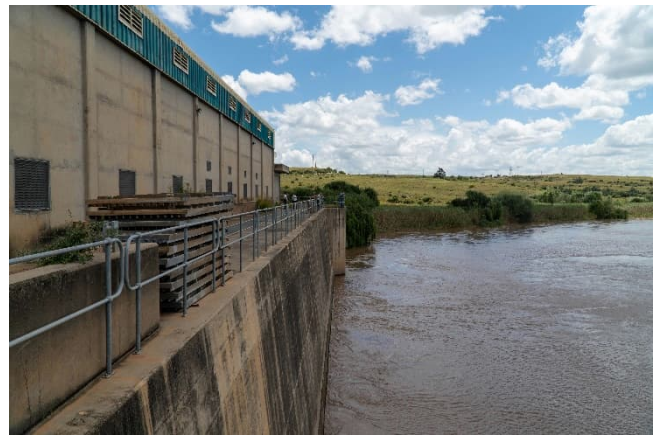
Figure 3-26: Abstraction inlet screening wall

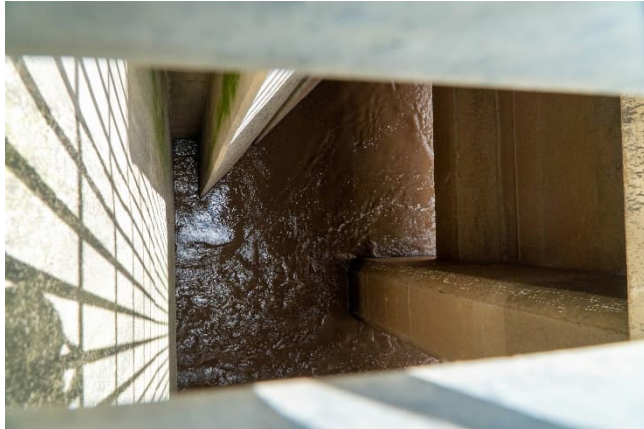
Figure 3-27: Inlet screening into pump sumps

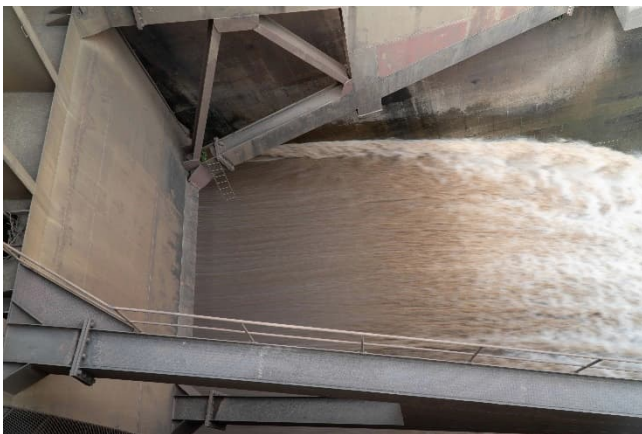
Figure 3-31: Sluice Gate 5 open

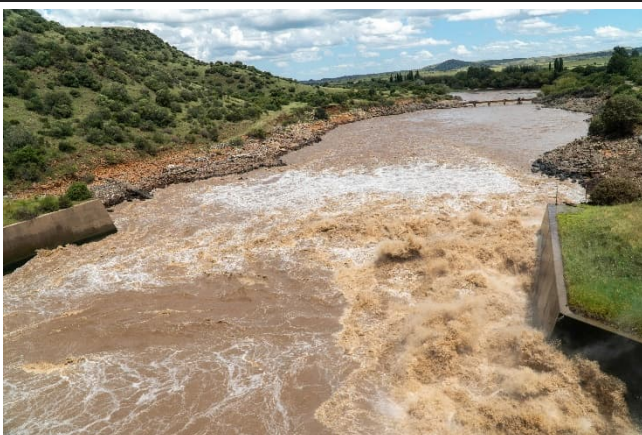
Figure 3-33: Evidence of downstream scouring and debris

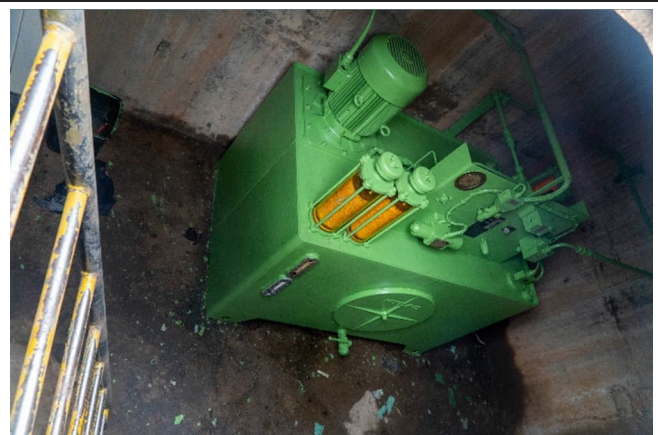
Figure 3-34: Newly painted hydraulic power pack

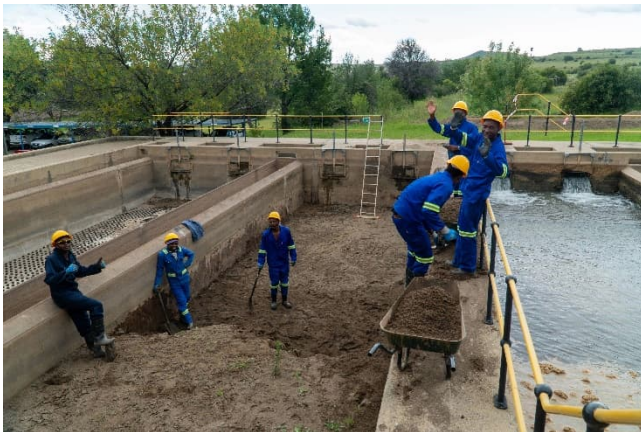
Figure 3-47: Refurbishment of filter under-drainage system in process

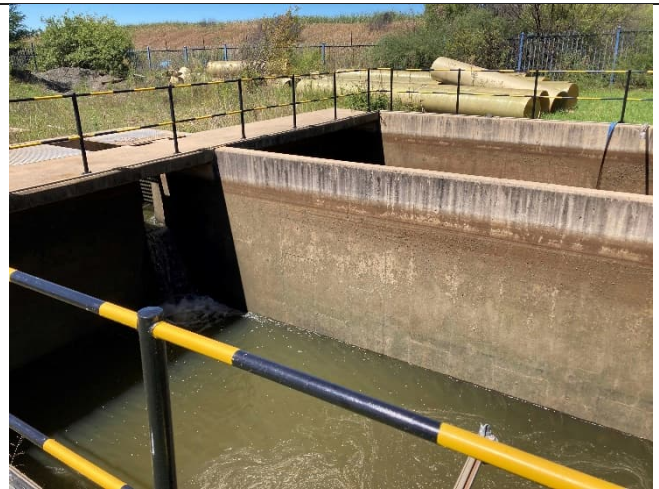
Figure 3-66: Residuals holding tanks

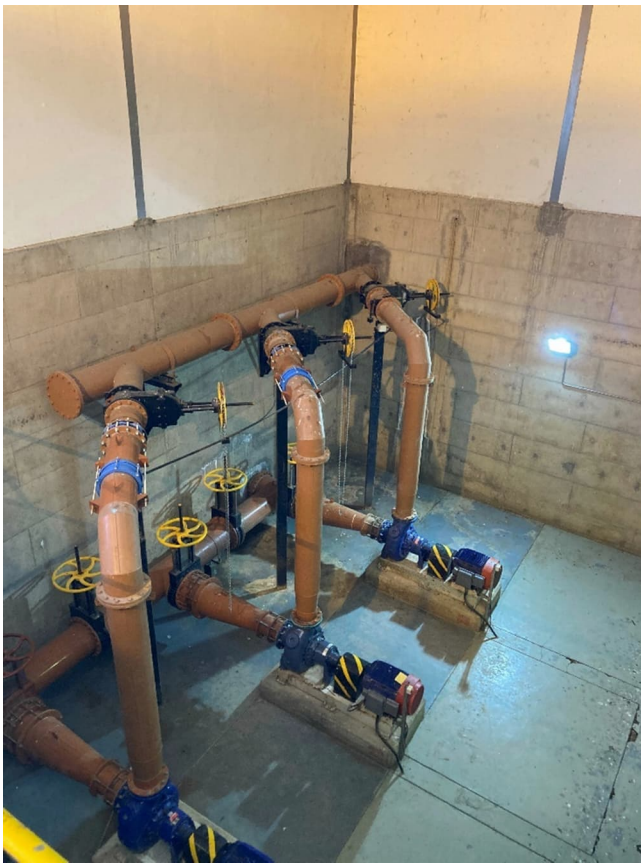
Figure 3-67: Residuals pump station

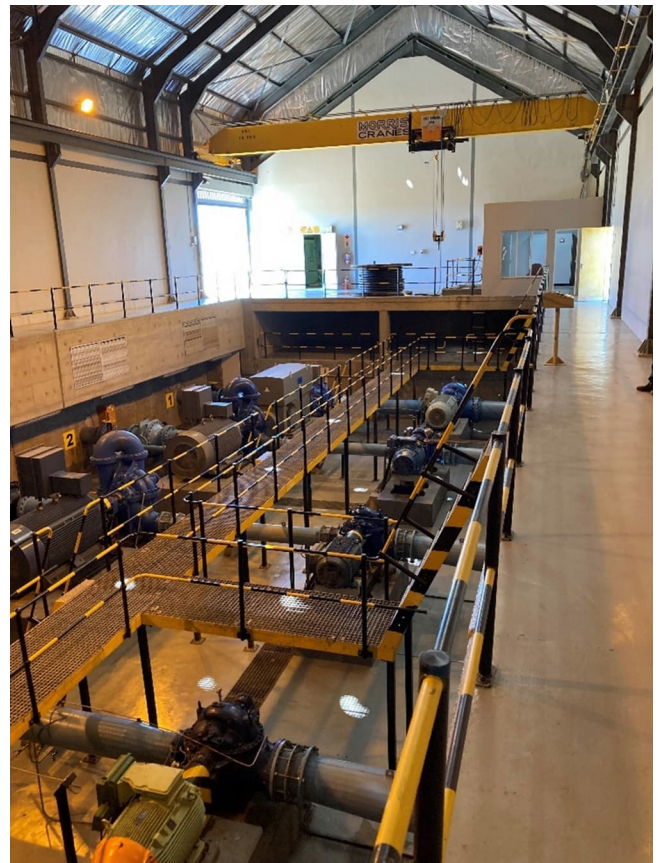
Figure 3-68: Final water pump station

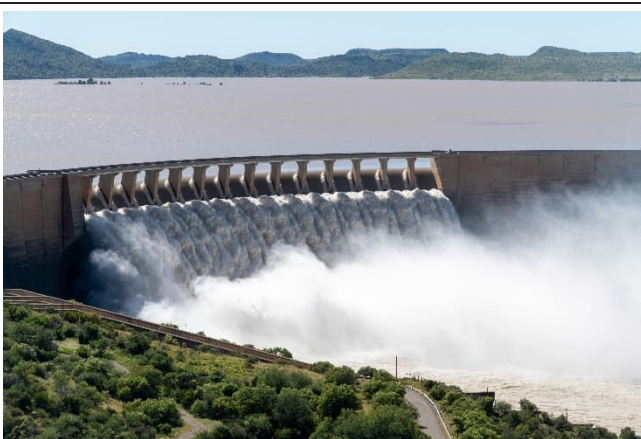
Figure 3-69: Gariep Dam Wall from the DWS Offices

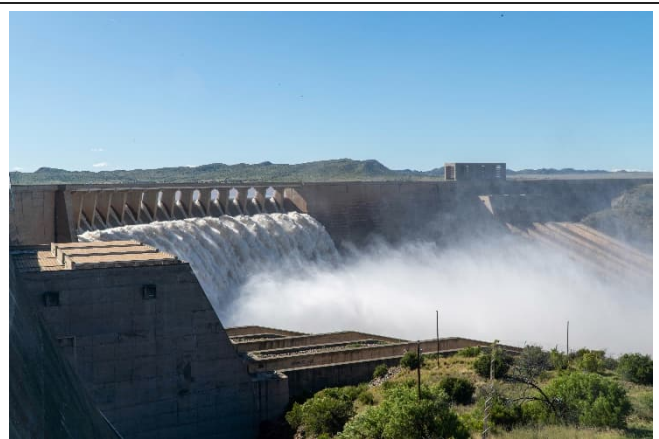
Figure 3-70: Gariep Dam Wall and Spillway

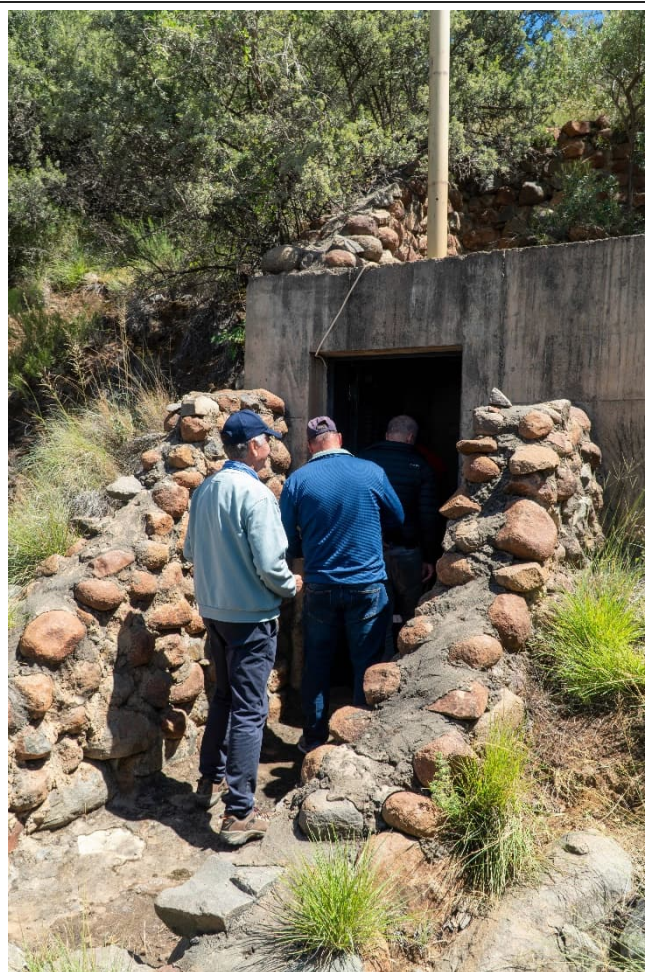
Figure 3-74: External shaft down to the connection pipes

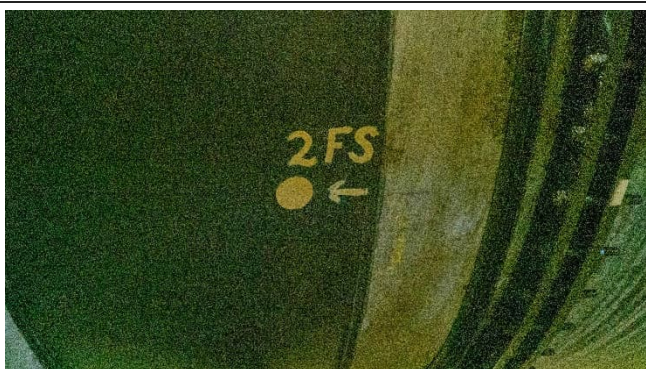
- These two 2.1m pipelines seemed to have been earmarked for connection to Bloemfontein.

Figure 3-75: Pipe No. 2 to Free State

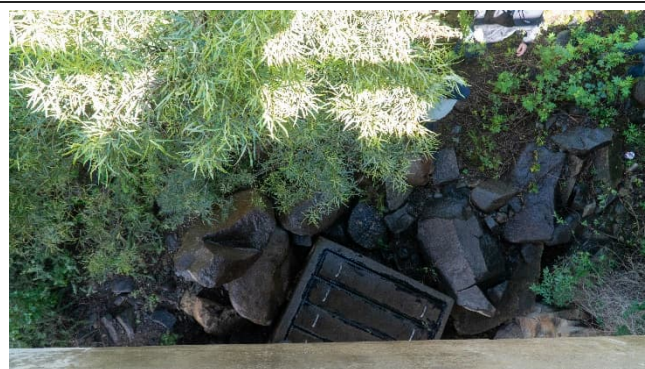
Figure 3-76: Smaller pipe feeding Xhariep WTP

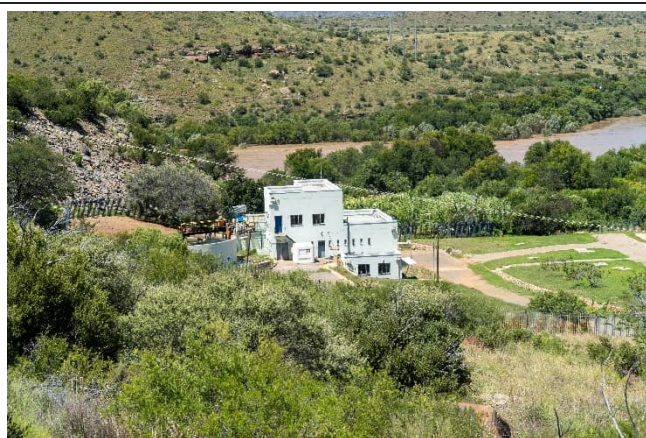
Figure 4-2: Gariep WTP

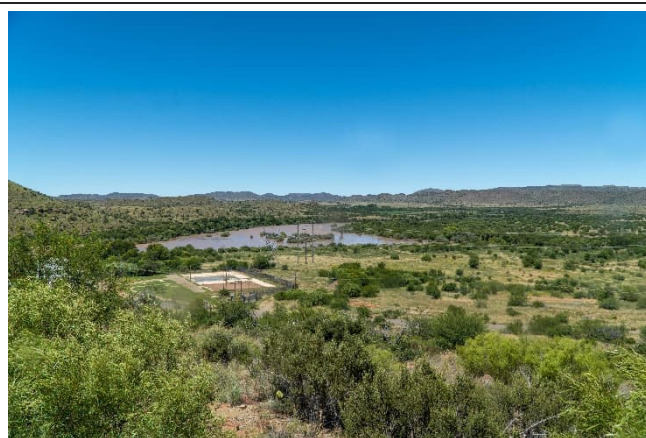
Figure 4-3: Southern end of potential site

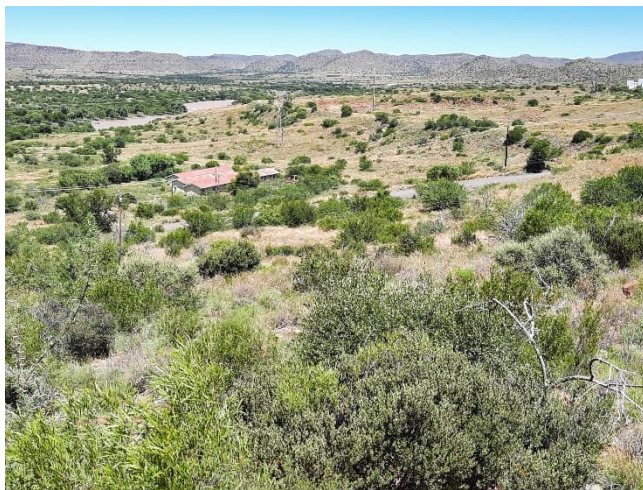
Figure 4-4: Middle of potential site

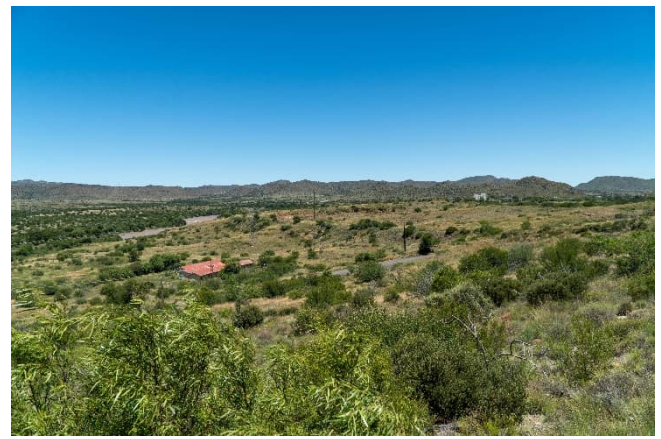
Figure 4-5: Northern end of potential site (alternative site to the right of existing structure)

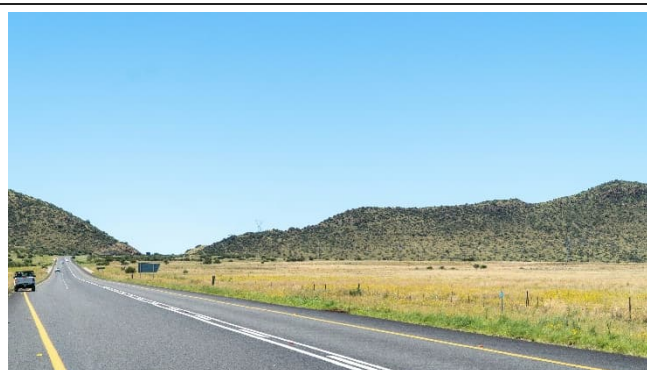
Figure 4-7: Location next to the N1

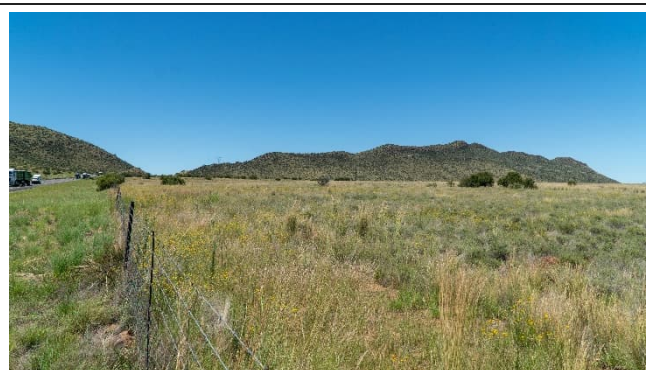
Figure 4-8: View towards the eastern boundary of the site

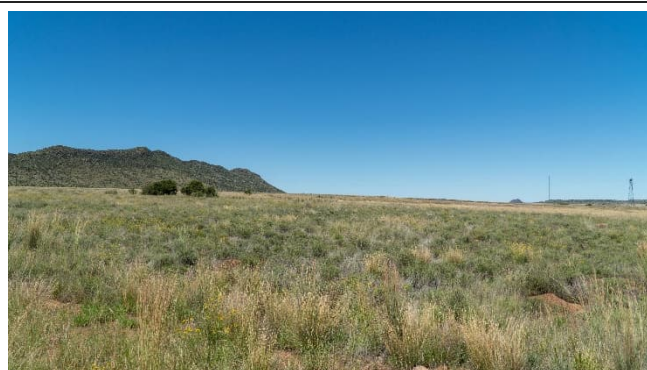
Figure 4-9: View of the middle of the site

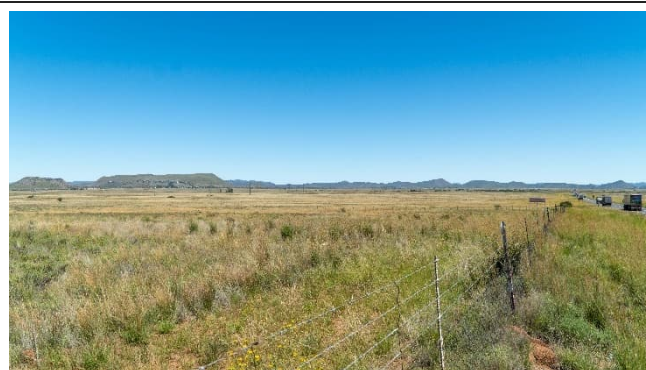
Figure 4-10: View towards the western boundary

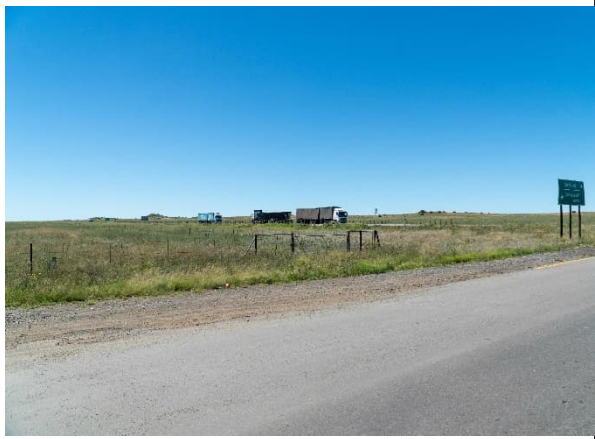
Figure 4-12: Existing intersection off N1 and eastern end of potential site

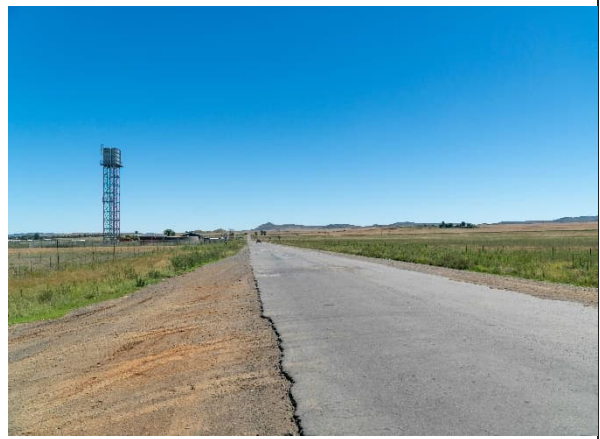
Figure 4-13: Site located before truck stop and Springfontein

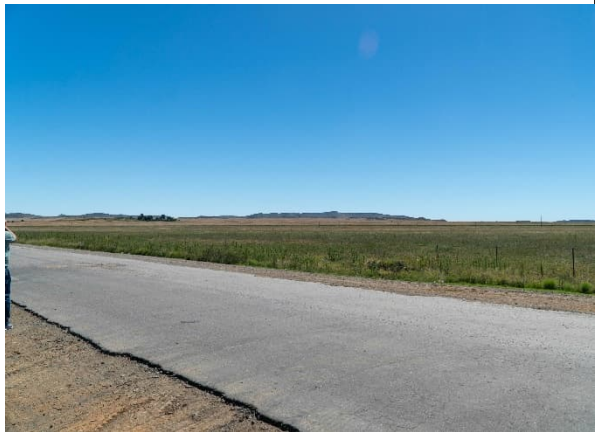
Figure 4-14: Western end of potential site

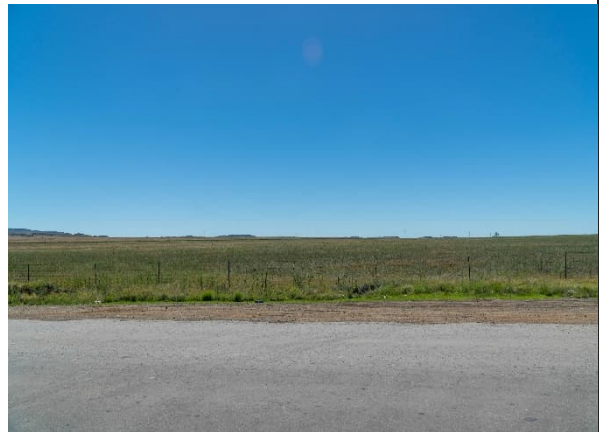
Figure 4-15: Middle of potential site
