Report Number: P WMA 06/D00/00/3423/2

# Greater Mangaung Water Augmentation Project Site Visit Report

## Xhariep Pipeline Feasibility Study

| <b>Date</b> | : | 04 September 2023 |

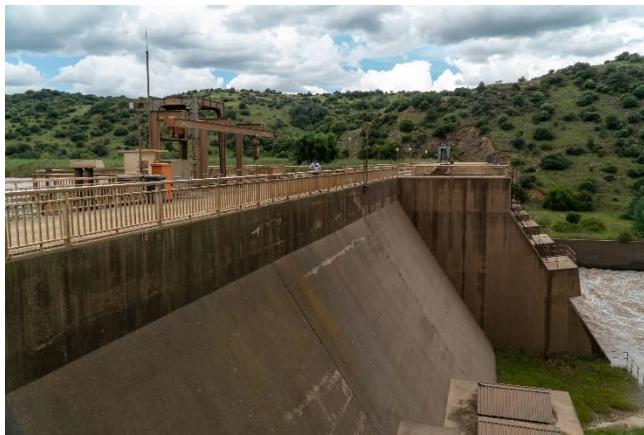
**Figure 3-29: Dam wall**

- ▶ Scouring efforts resulted in scouring at toe of dam wall due to the sluices not functioning and unbalanced release of the water.
- ▶ Scouring at the downstream side of the dam wall is evident.

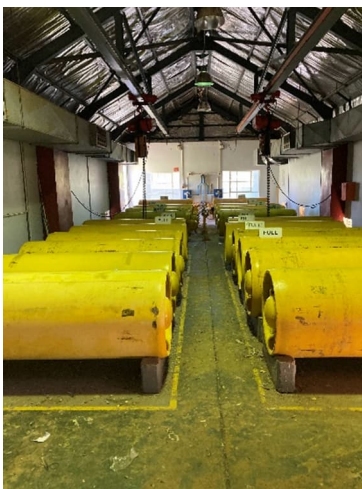
**Figure 3-65: Chlorine drums**

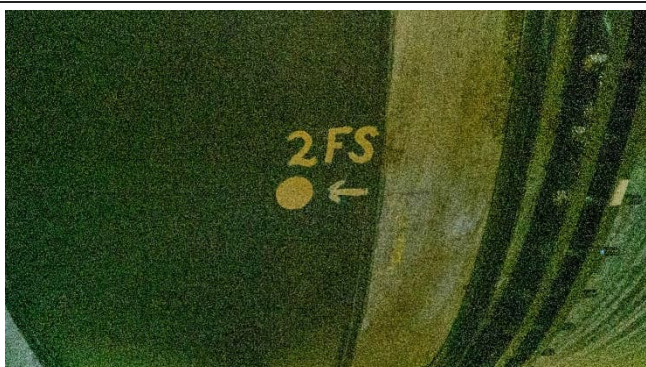
Figure 3-75: Pipe No. 2 to Free State

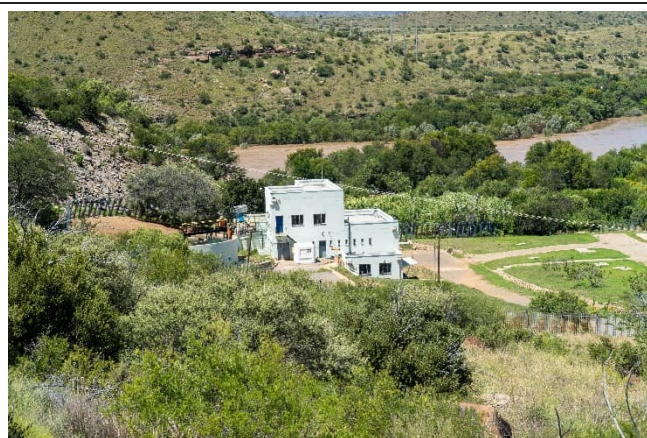
Figure 4-2: Gariep WTP

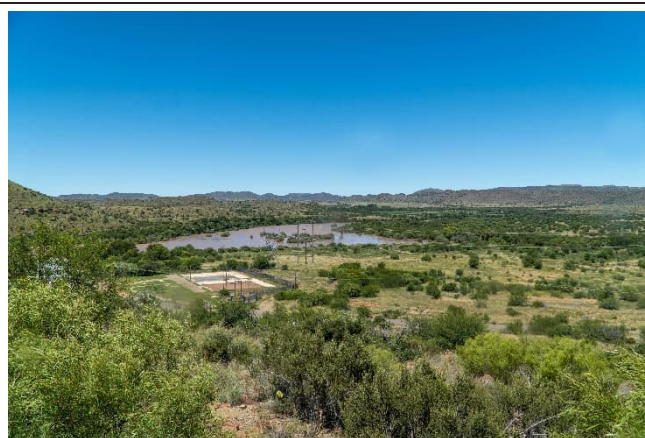
Figure 4-3: Southern end of potential site

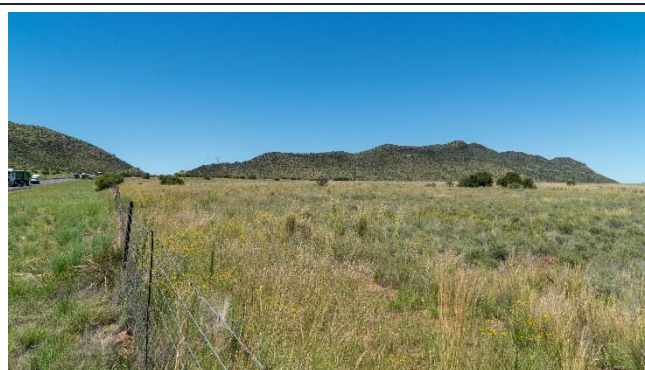
Figure 4-8: View towards the eastern boundary of the site

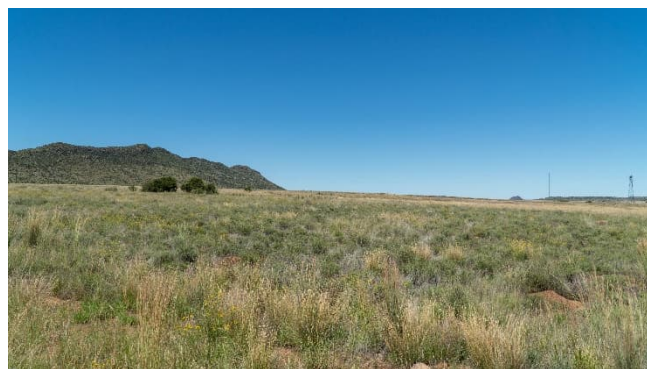
Figure 4-9: View of the middle of the site

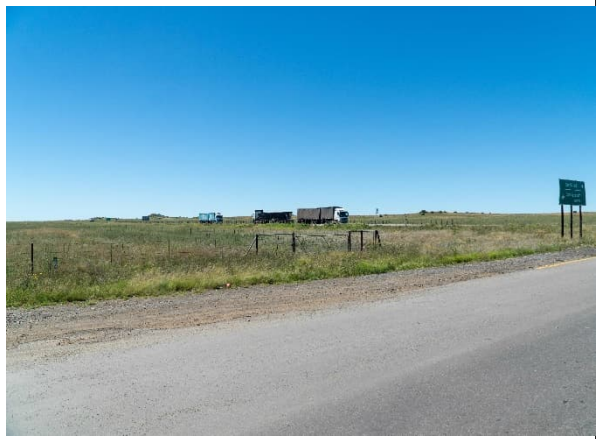
**Figure 4-12: Existing intersection off N1 and eastern end of potential site**

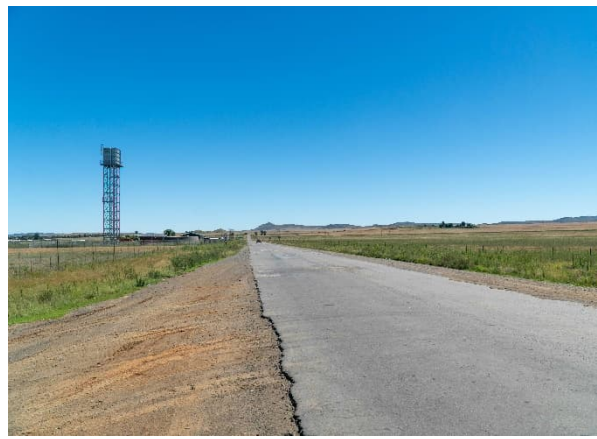
**Figure 4-13: Site located before truck stop and Springfontein**

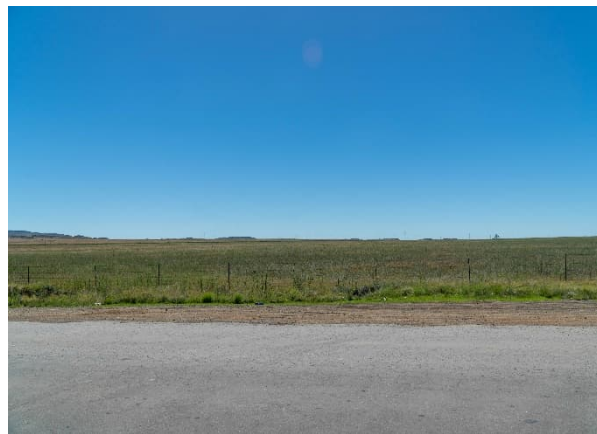
**Figure 4-15: Middle of potential site**
